# EFFECT OF CORROSION RESISTANT COATINGS ON THE FATIGUE STRENGTH OF CAST MAGNESIUM ALLOYS

James J. Bethke  
Air Vehicle Technology Department  
NAVAL AIR DEVELOPMENT CENTER  
Warminster, Pennsylvania 18974

1 SEPTEMBER 1977

FINAL REPORT  
CUSTOMER PROJ. NO. EJ-4-H0042-EJ-F6

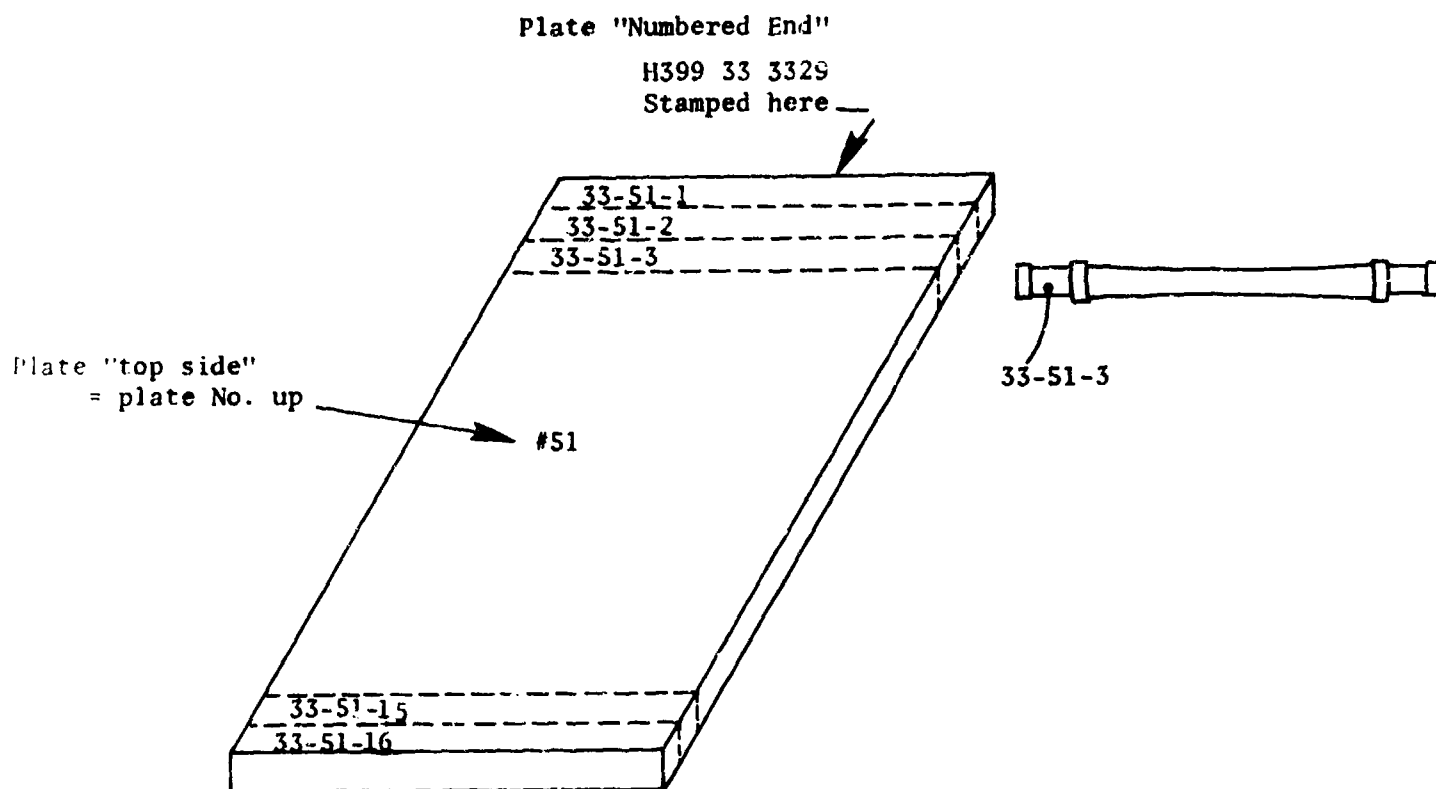
Figure 2. Magnesium Cast Plate Sectioning for R. R. Moore Specimens; and Identification Scheme

All specimens were numbered; each specimen number determined by the alloy number, plate number, and location in the plate from which it was taken. Specimens taken from each plate were numbered 1 to 16 depending upon their location with respect to the plate numbered end: The #1 specimen being from the numbered end.

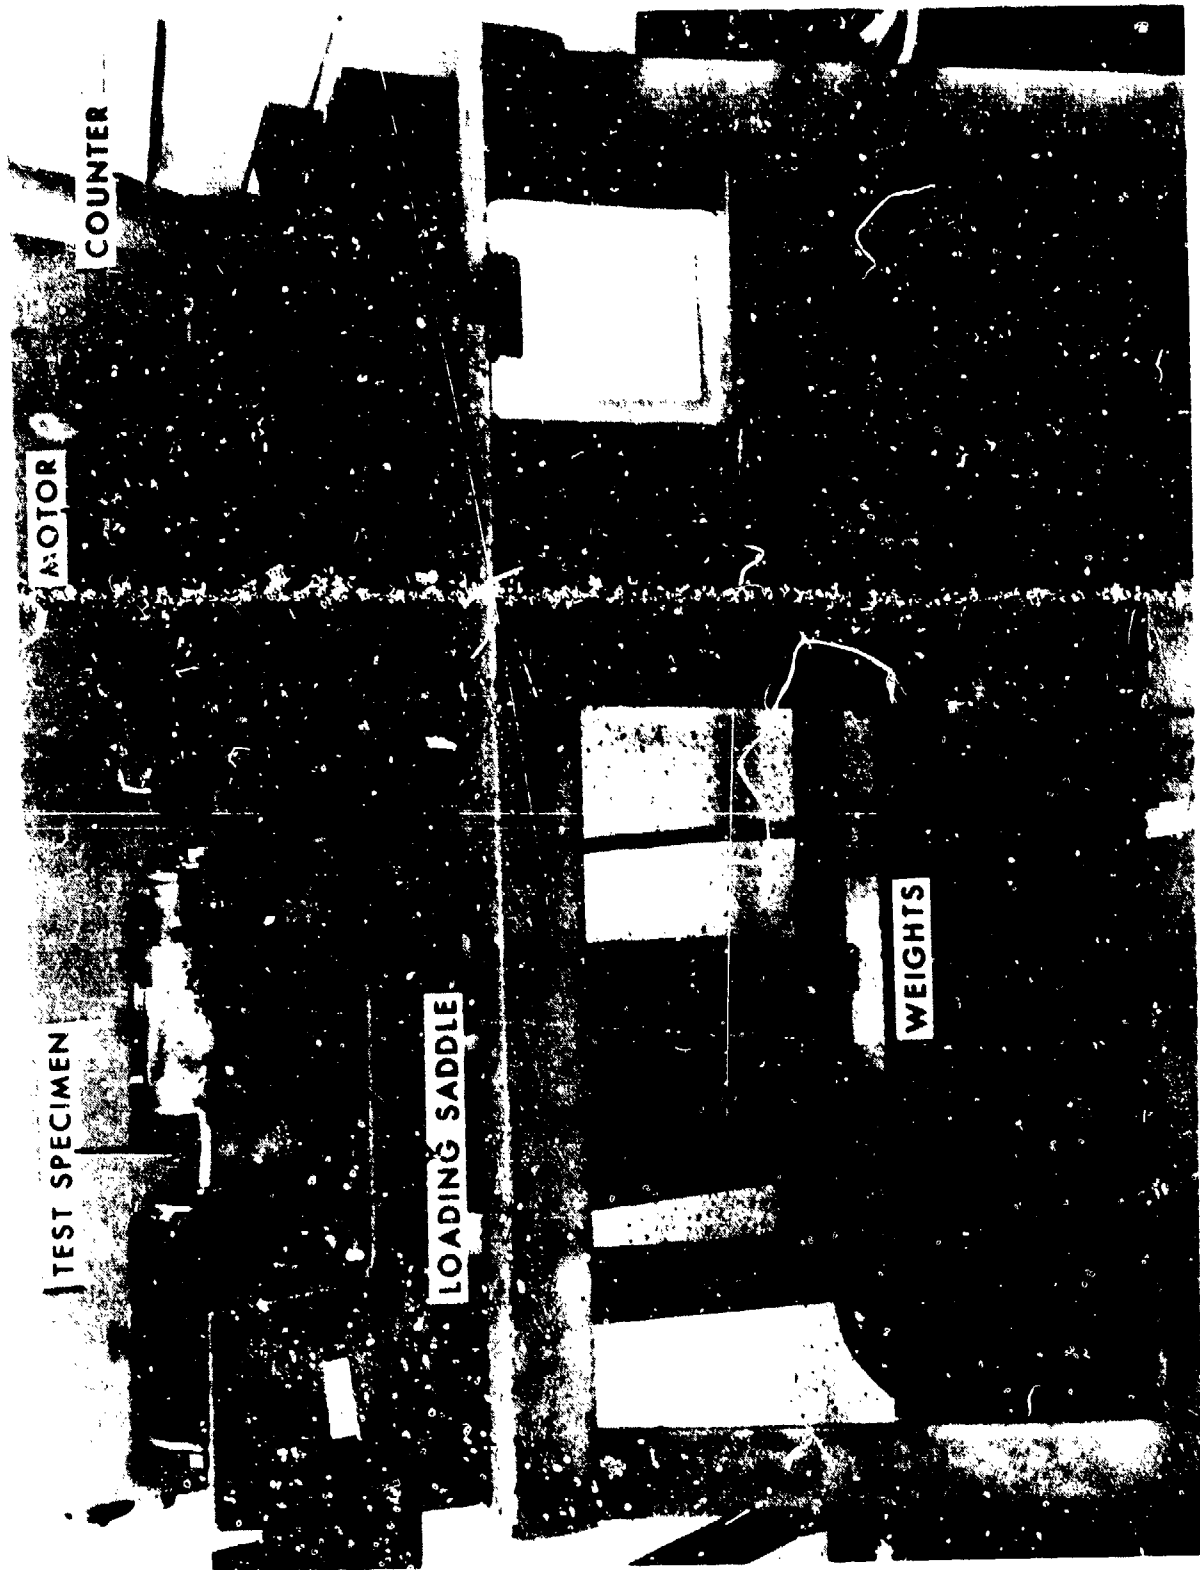
Figure 4 - Close-Up of R. R. Moore Rotating Beam Fatigue Test Machine

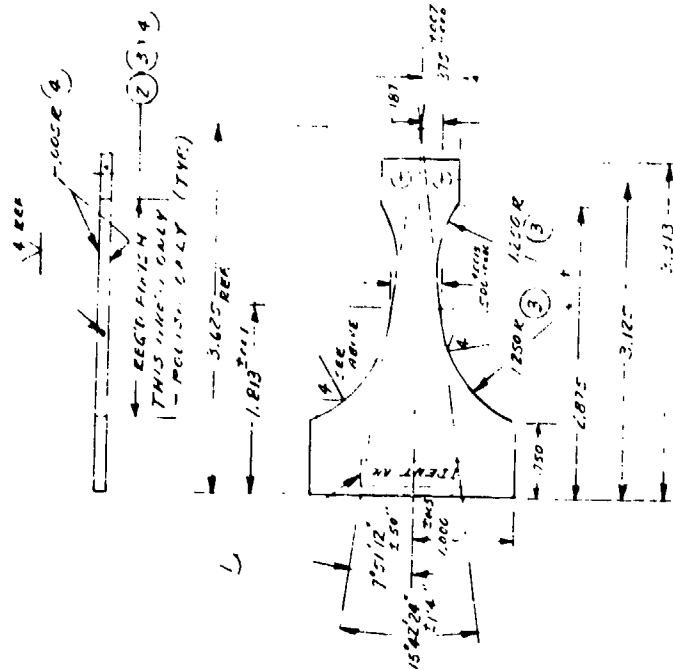
- (1) SPECIMEN SHALL BE IDENTIFIED IN  
HUMAN SPECIMEN, ACCORDING TO SCHEME  
PREPARED BY TEST ENGINEER.
- (2) ALL SIDES LONGITUDINALLY WITH SUC-  
CESSIVELY LIGHTER CUTS (LAST 2 CUTS  
0.003 OR LESS) WHEN APPROACHING DIM'S  
SHOWN, TO PRECLUDE UNDESIRABLE  
CELL WORKING & CLERKENING OF ANGLE.  
THIN ARE TO BE ELEATED WITH  
TANGENT LINES IN THE CENTRAL  
AREA, NO DISCONTINUITY PERMITTED.
- (3) GIVE A SHARP EDGES AS IN 1, 2, 3, 4, 5, 6, 7  
WITH FINISH SHOWN, TOLISM IN  
LONGITUDINAL DIRECTION ONLY. NO  
NICKS, MARKS OR SCRATCHES TO  
BE ALLOWED.

Figure 5(a) - 1/8-In. (3.2mm) Thick Sheet Flexure Fatigue Test Specimen

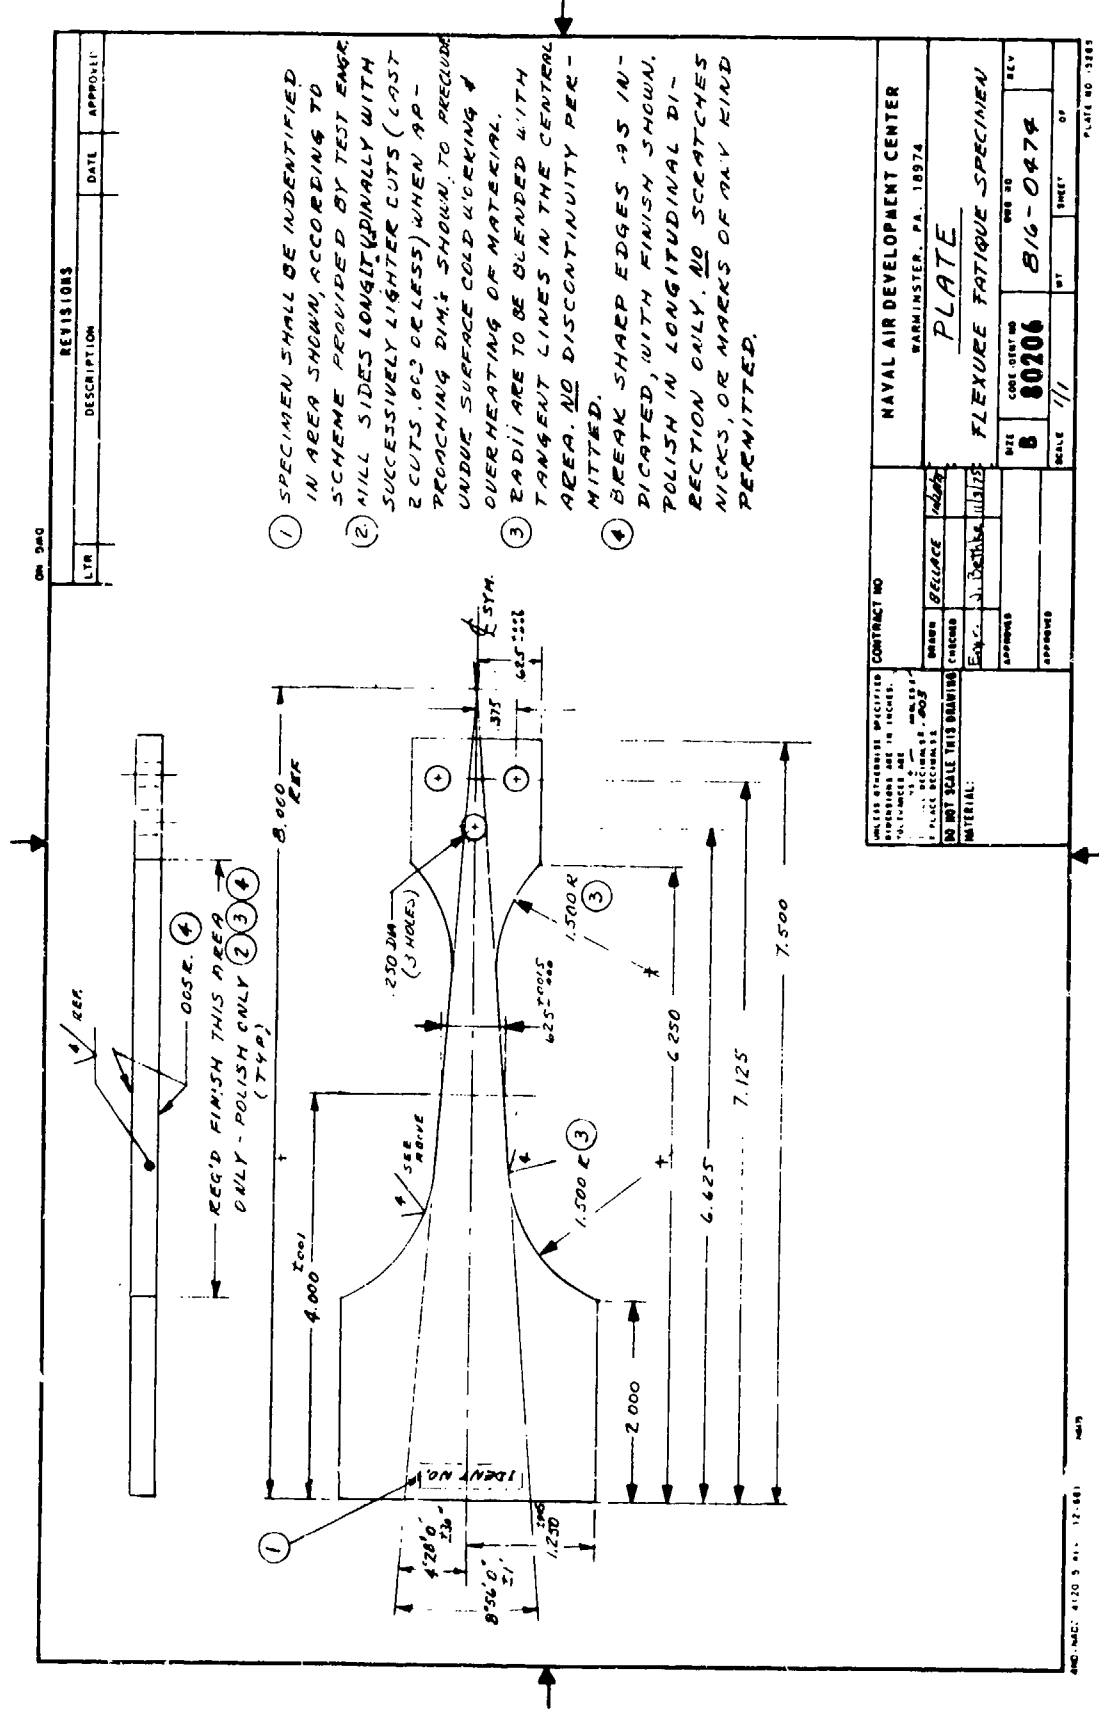
**Figure 5(b) - 1/4-In. (6.4mm) Thick Sheet Flexure Fatigue Test Specimen**

1. Same as for 1/8-in. (3.2 mm) thick specimens except:
  - a) no surface grinding of the 5-1/4-in. x 8-in. x 1/4-in. thick (133 mm x 203 mm x 6.4 mm thick) cast plate is required,
  - b) lay out plate for two specimens,
  - c) use 2X pattern.

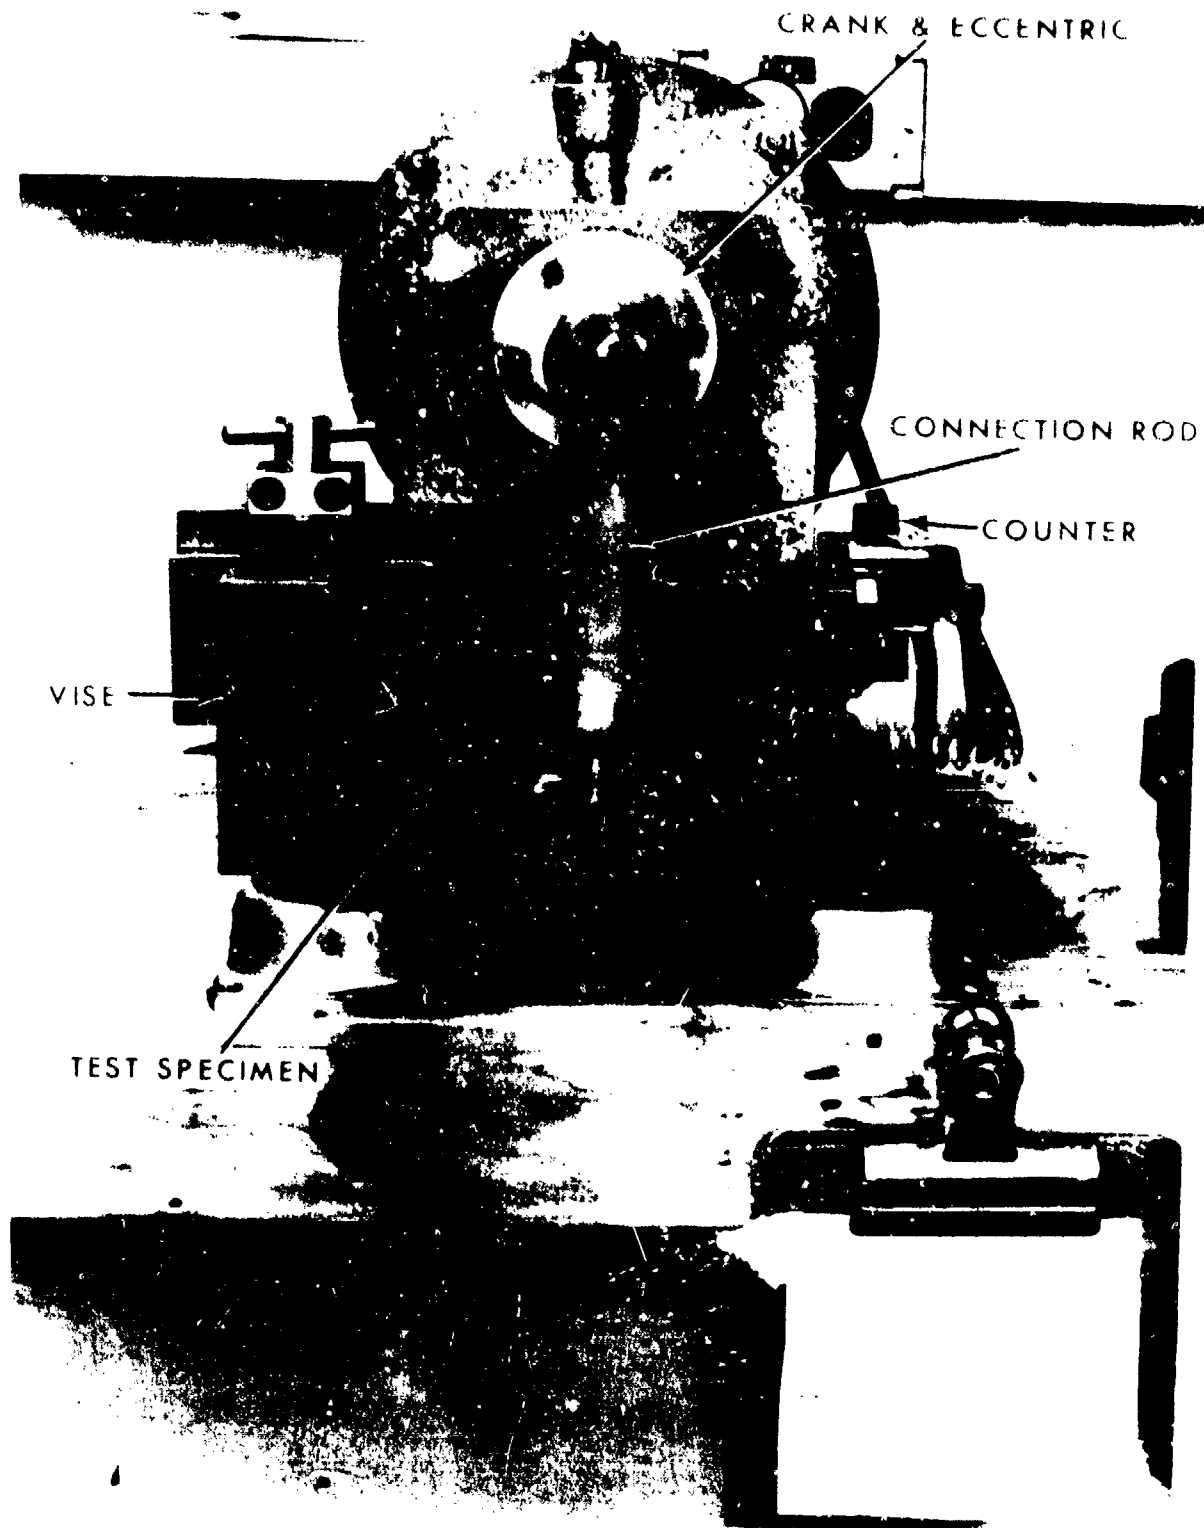
Figure 7 - Close-Up of 40 Lb. (178 N) Capacity Sheet Flexure Test Machine Showing Test in Progress

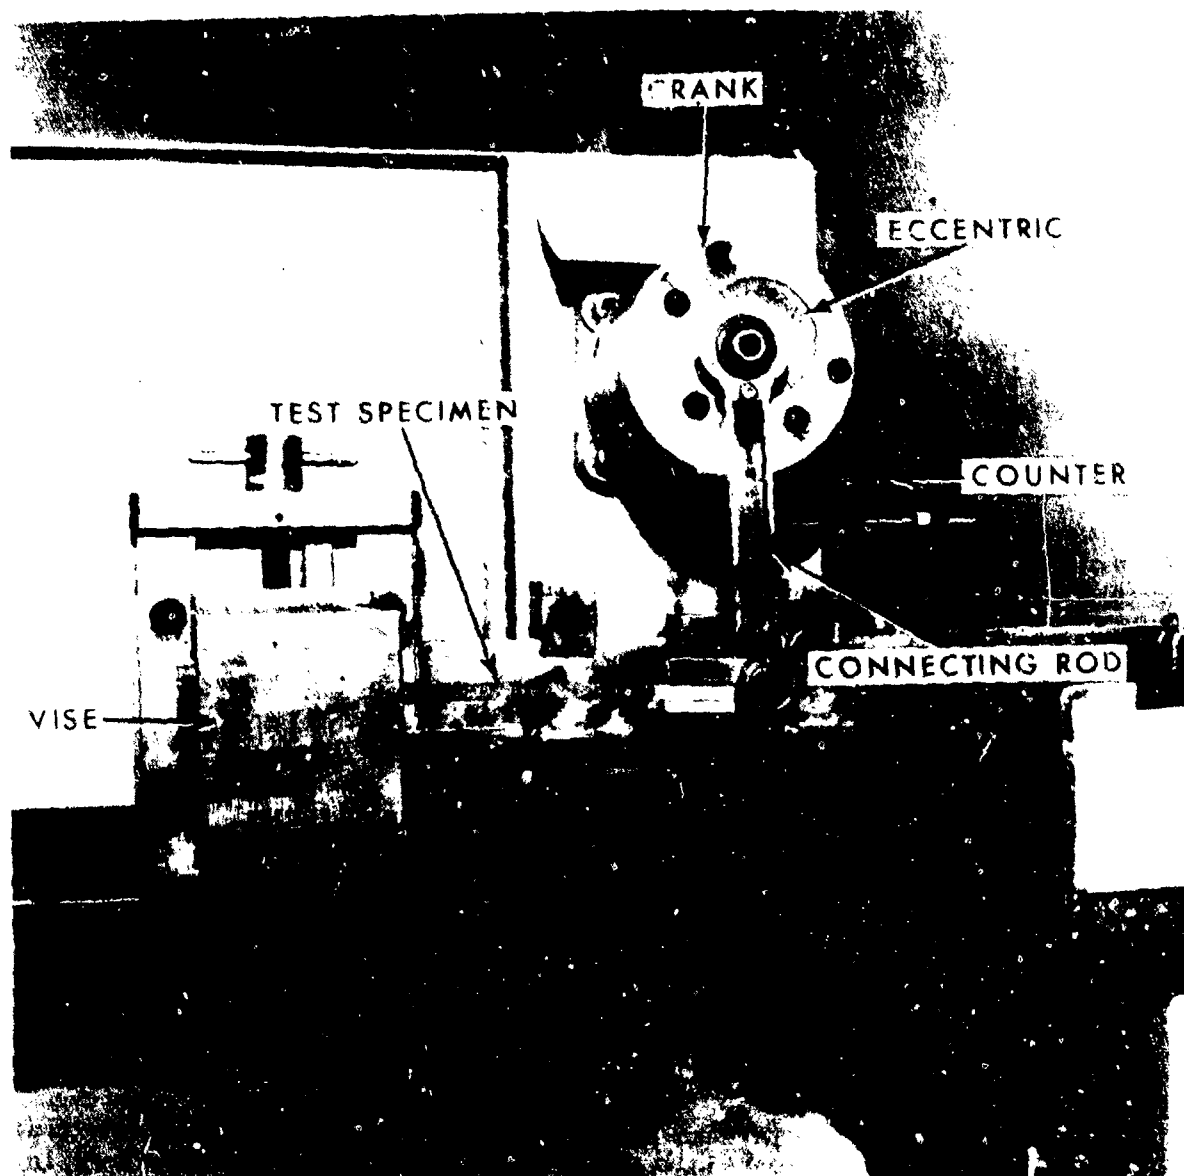
Figure 8 - Close-Up of 150 Lb. (668 N) Capacity Sheet Flexure Fatigue Test Machine

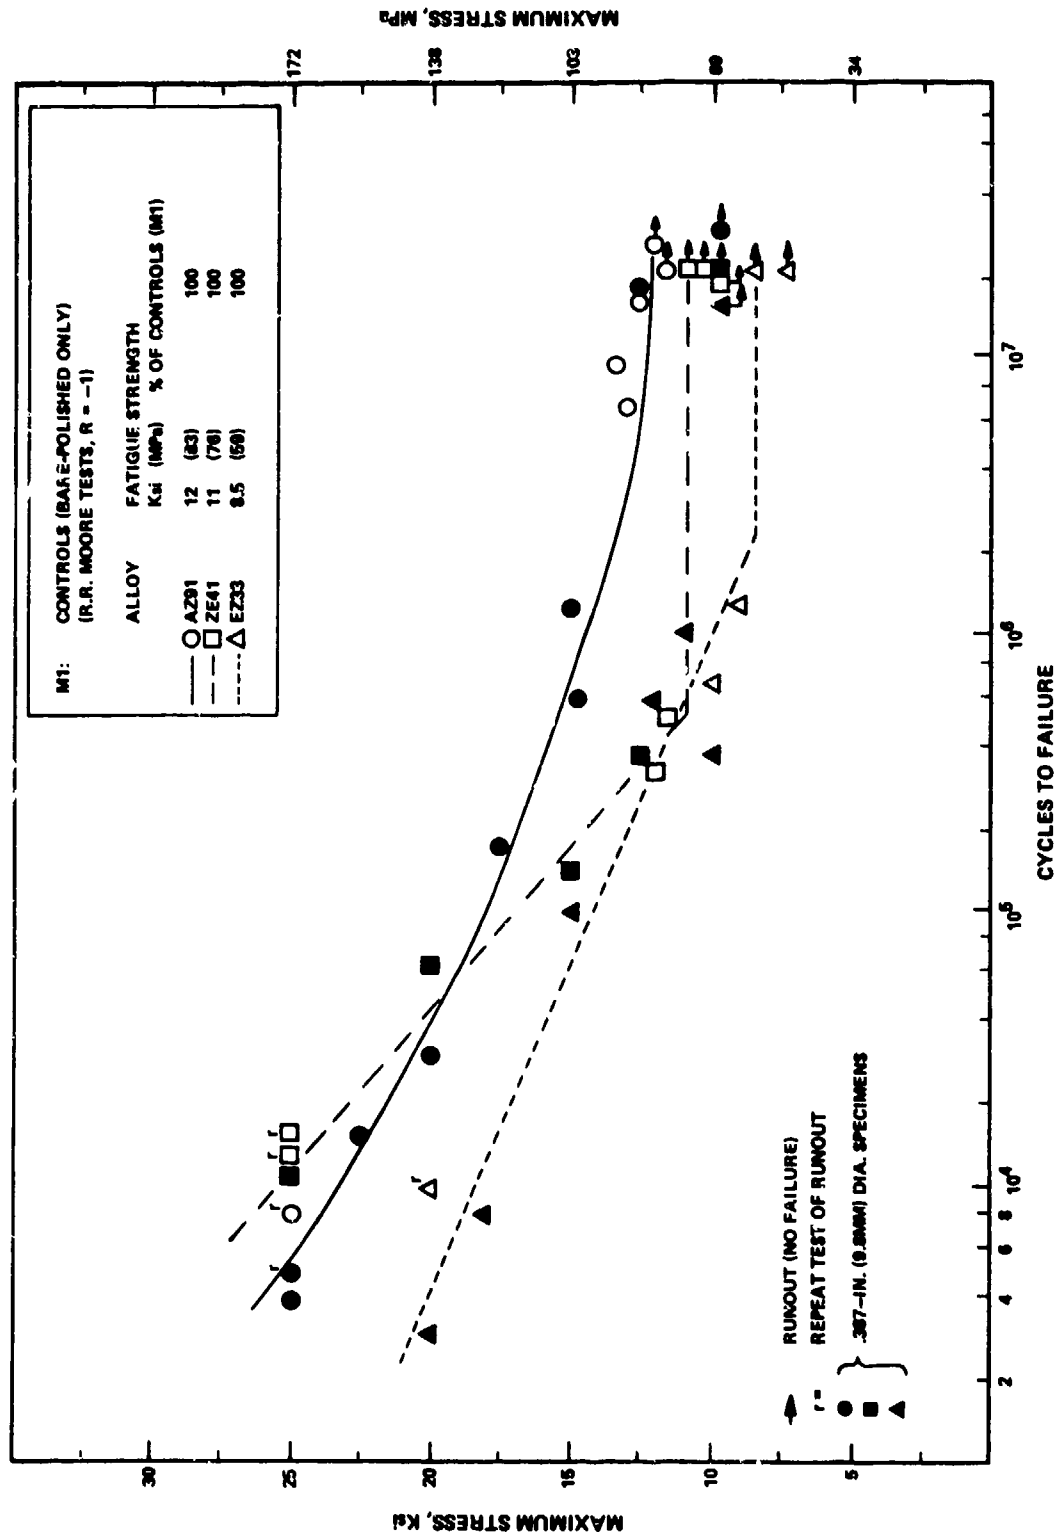
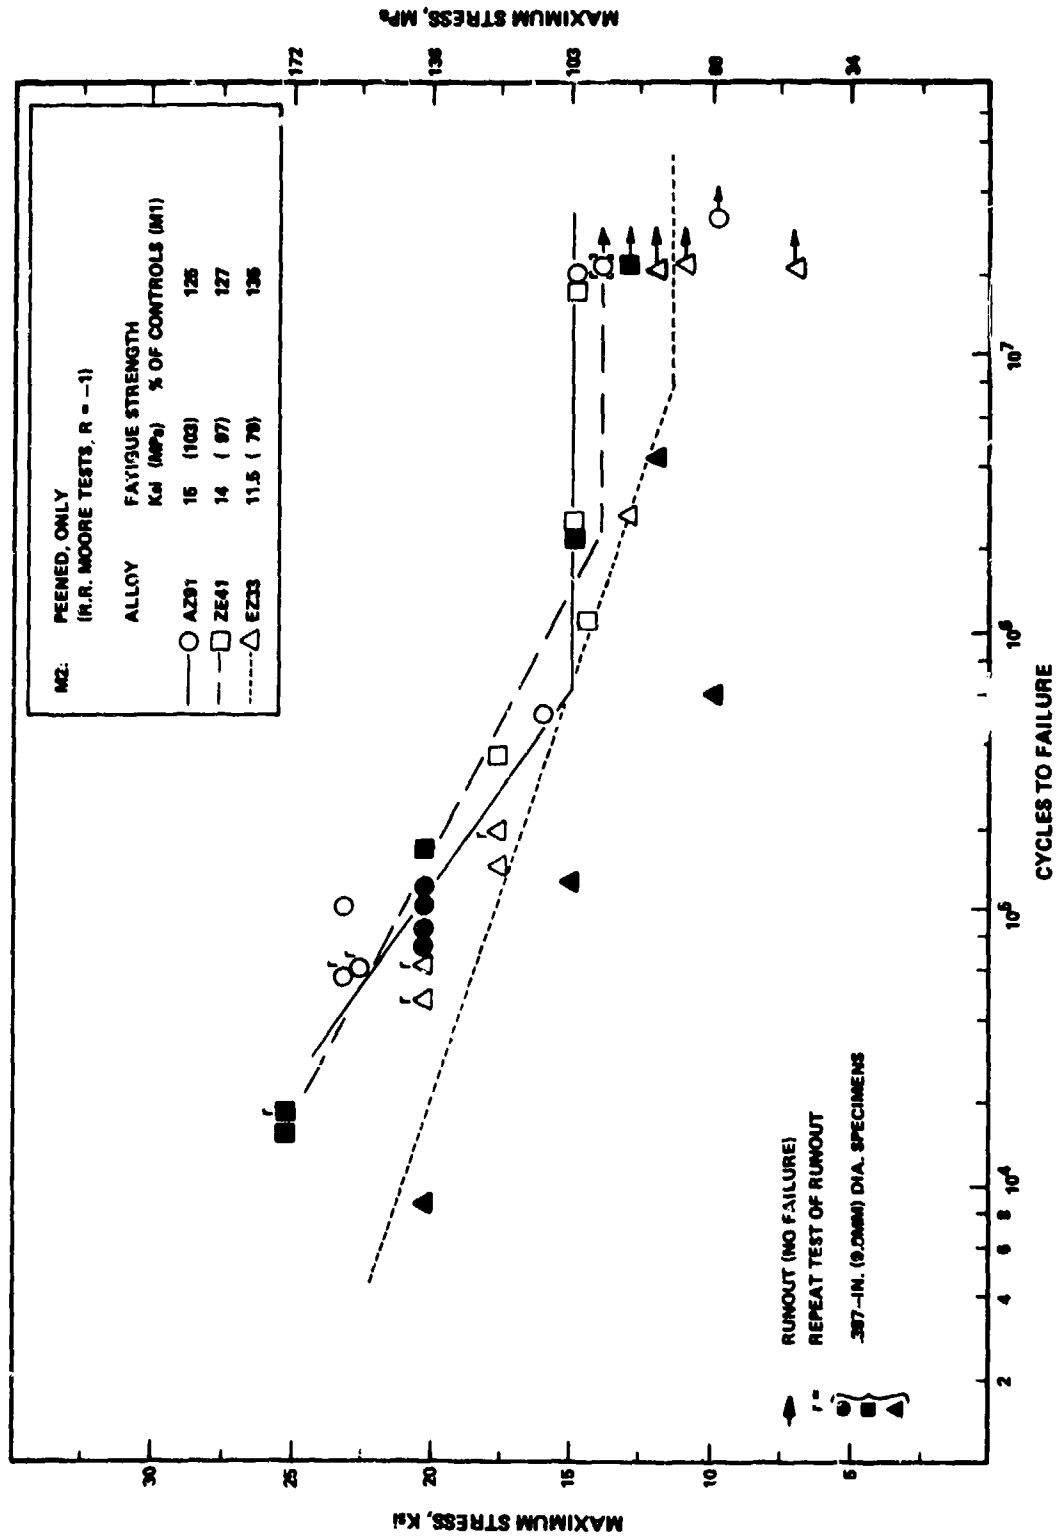
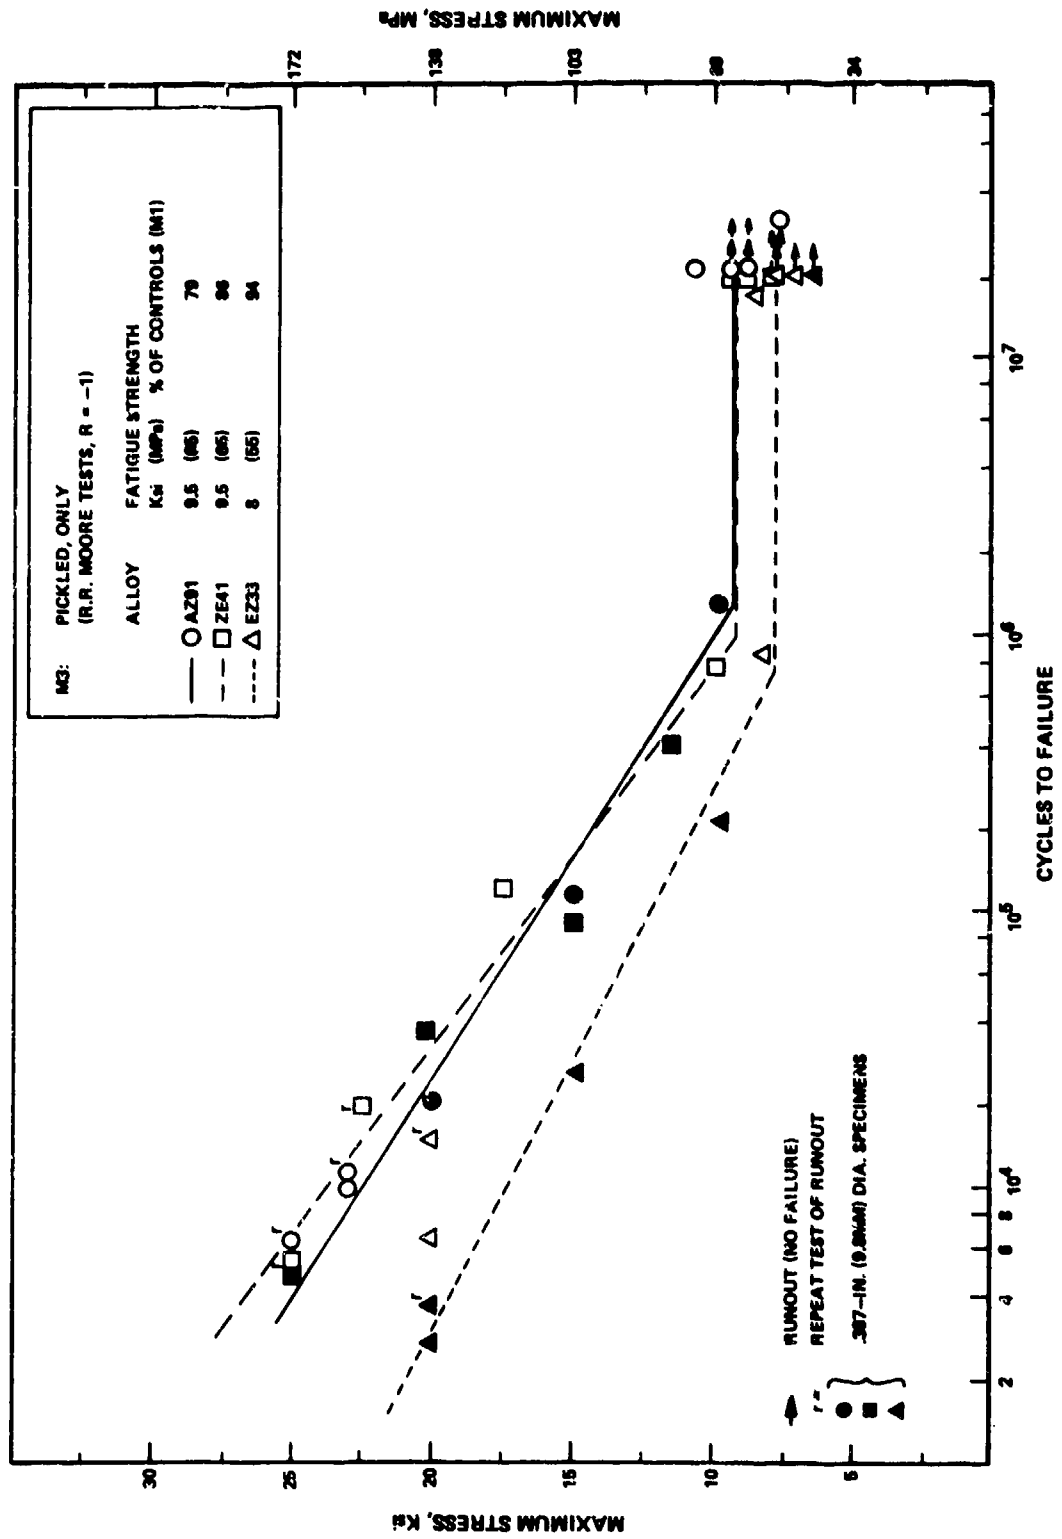
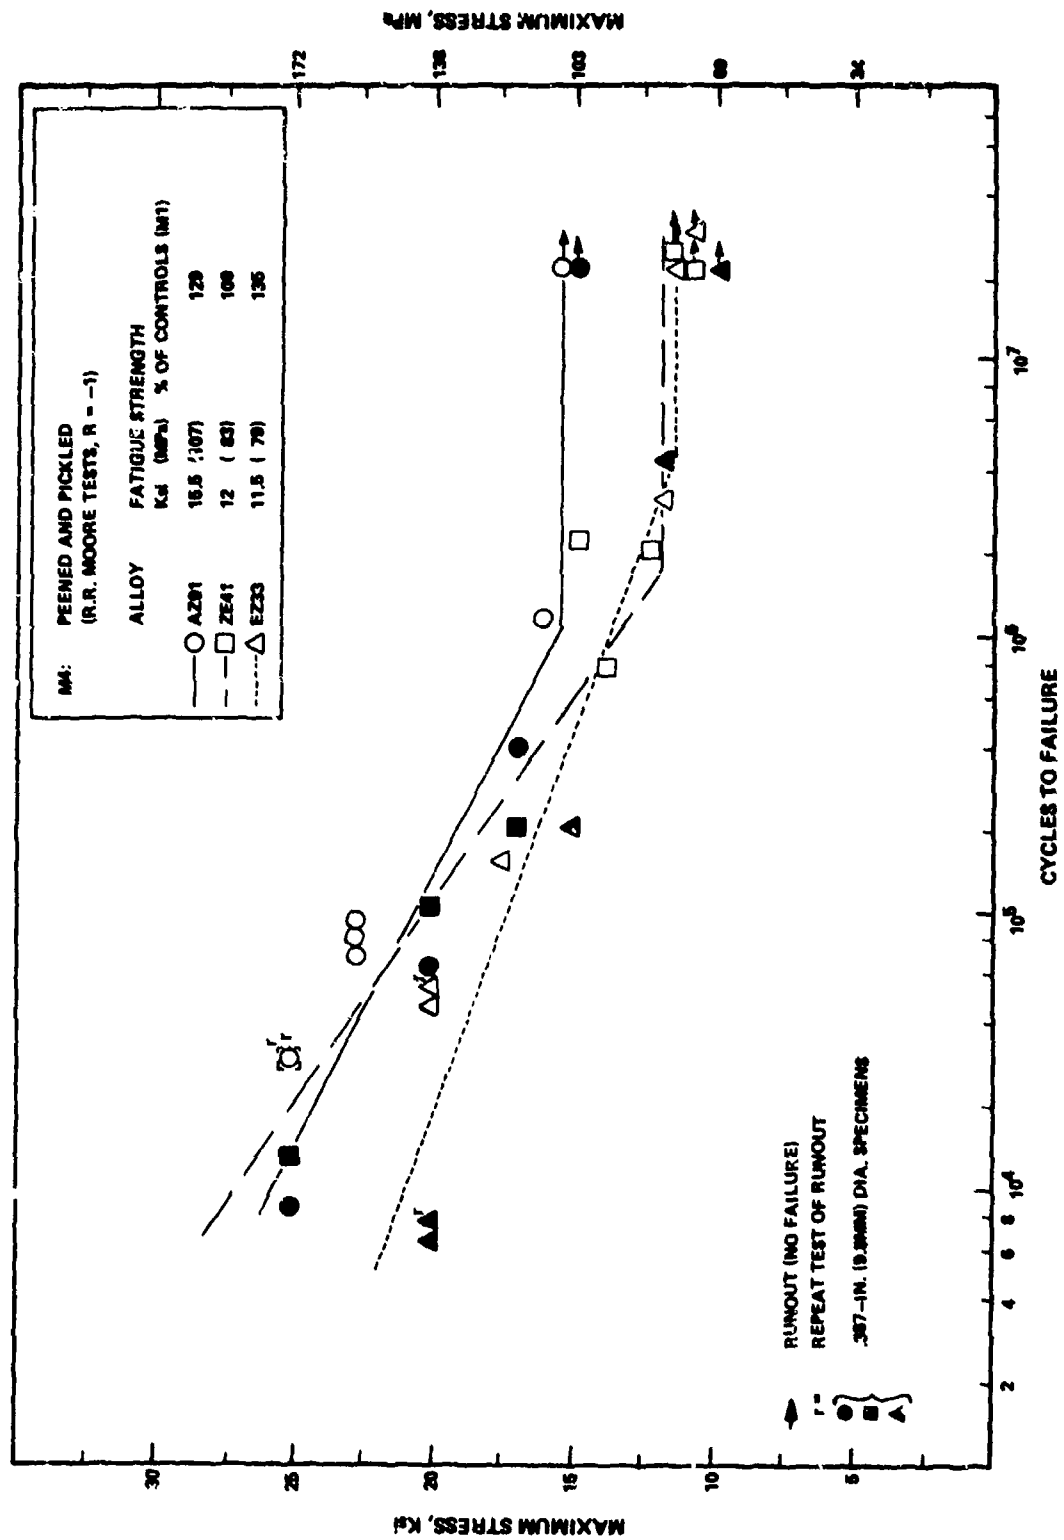
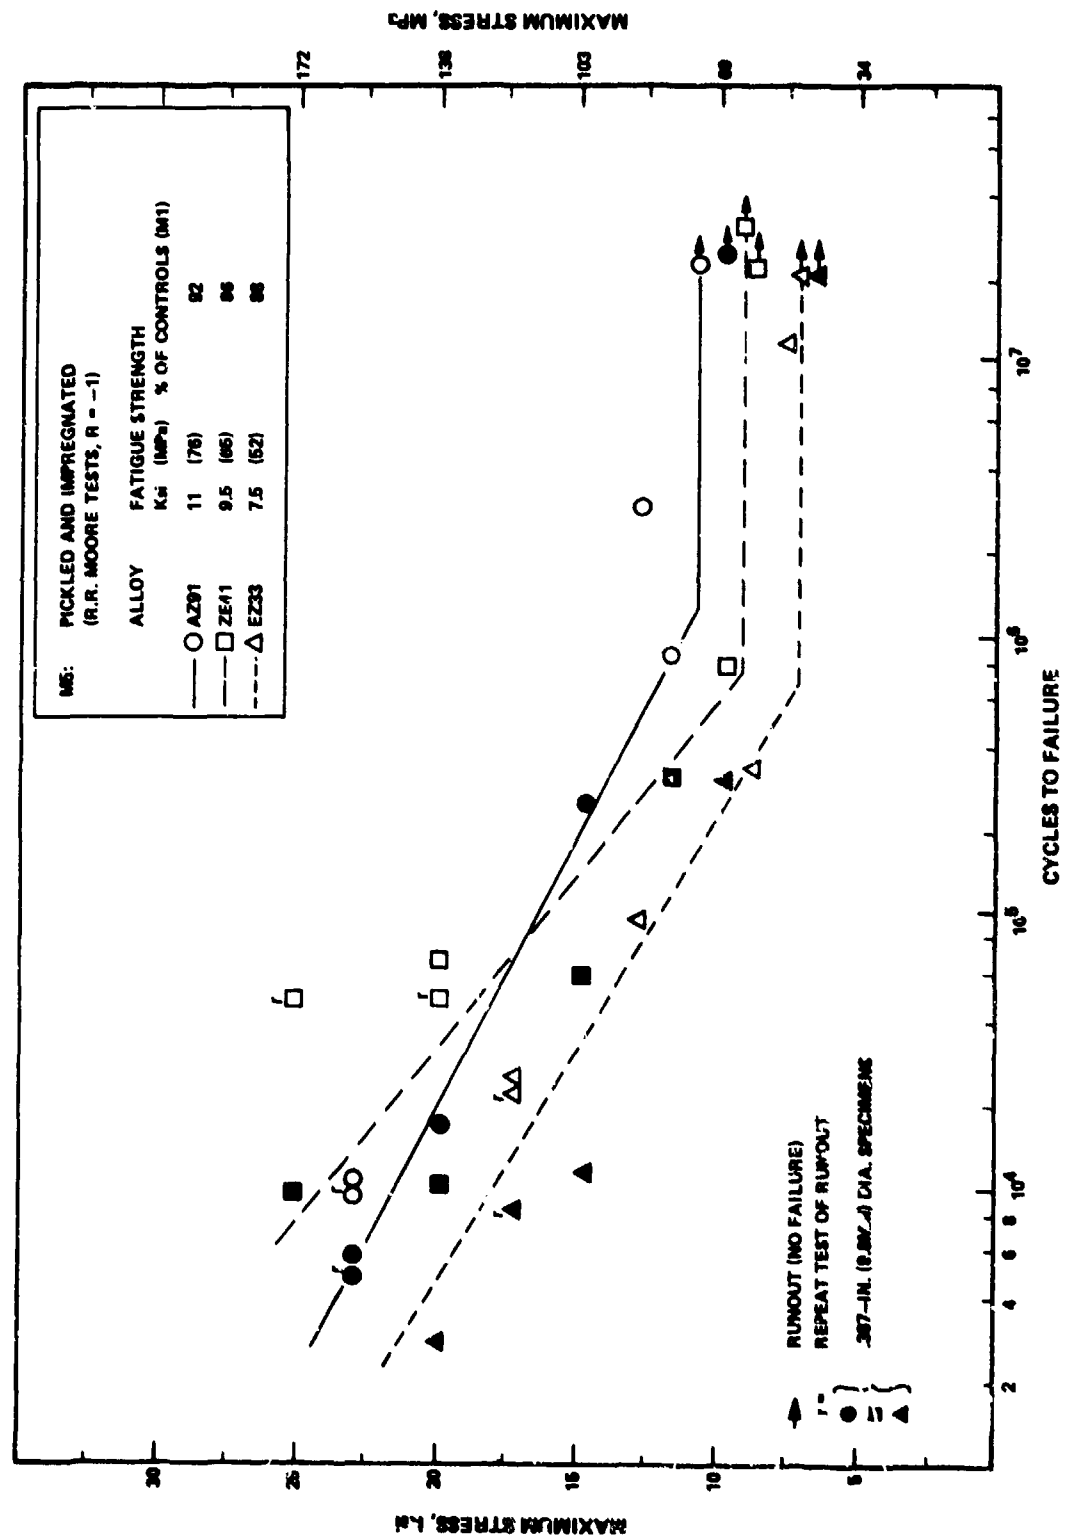
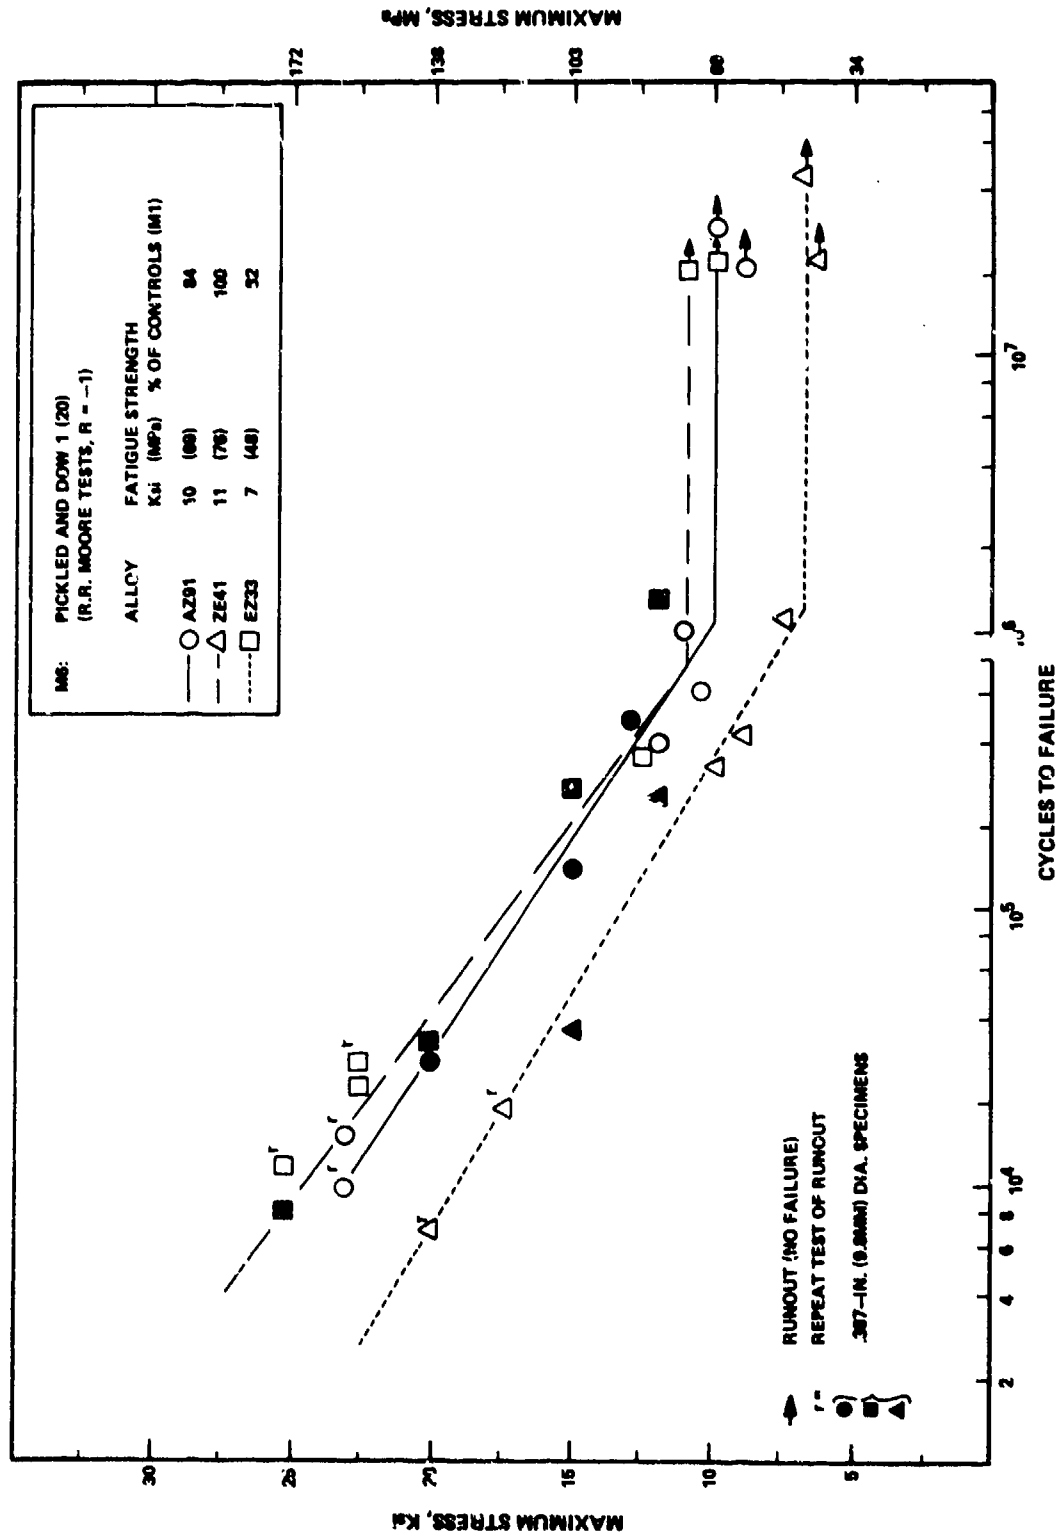
Figure 9 - R. R. Moore Fatigue Test S-N Curves

Figure 10 - R. R. Moore Fatigue Test S-N Curves

Figure 11 - R. R. Moore Fatigue Test S-N Curves

Figure 12 - R. R. Moore Fatigue Test S-N Curves

Figure 13 - R. R. Moore Fatigue Test S-N Curves

Figure 14 - R. R. Moore Fatigue Test S-N Curves

This is consistent with expectations since treatments which affect the substrate surface affect the crack nucleation stage of fatigue and therefore are most influential in the low stress - high cyclic life tests; hence the observed effect of peening to decrease the stress - cyclic life slope.

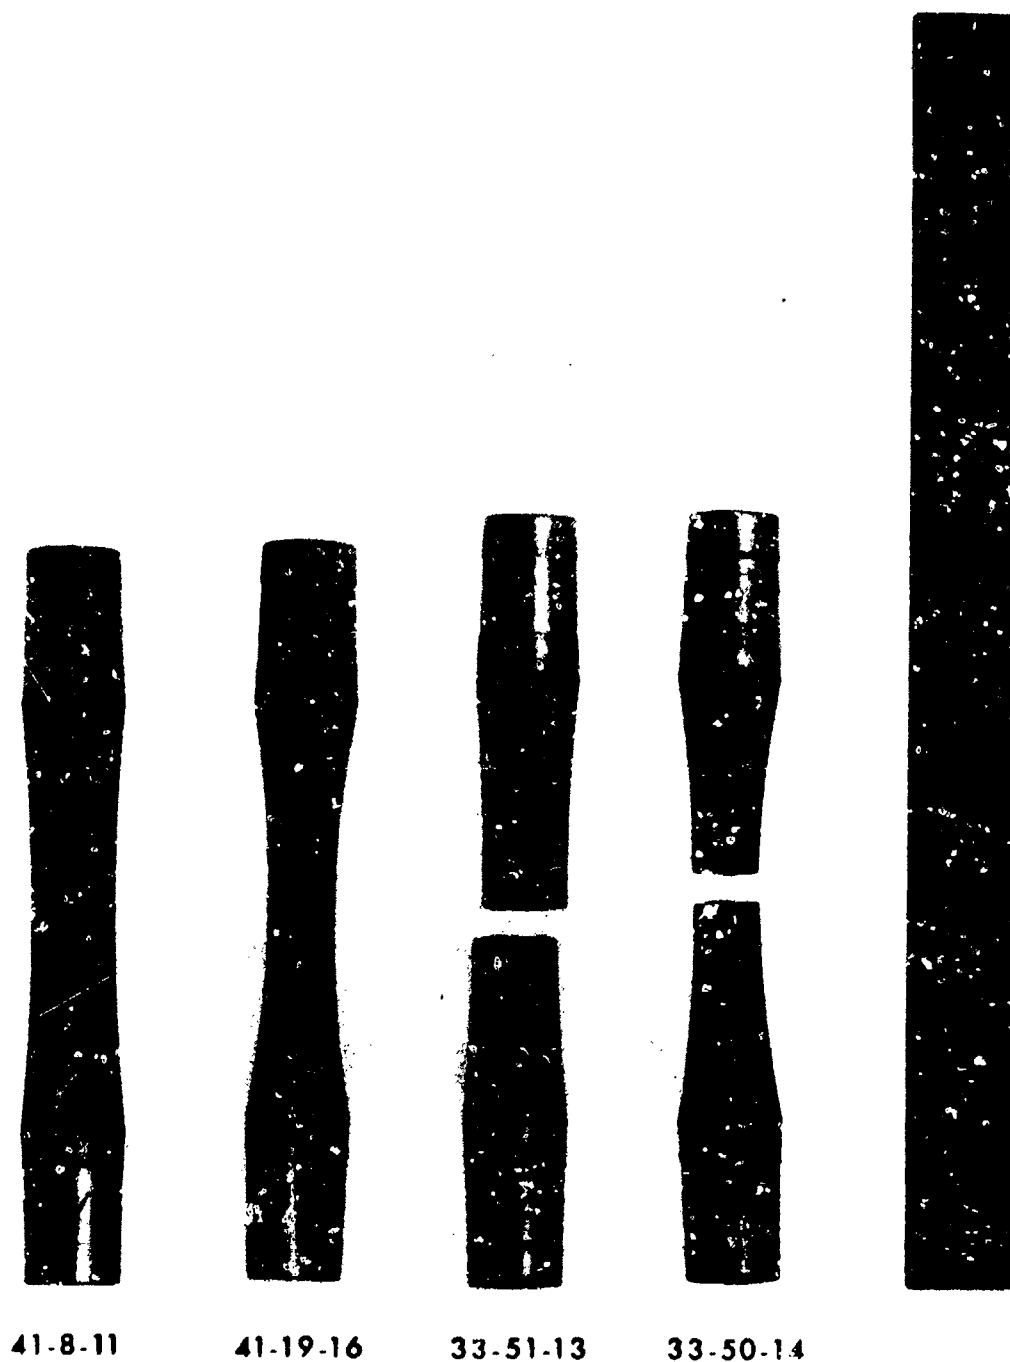
Figure 30 - Typical R. R. Moore Rotating Beam Fatigue Test Specimens, Large and Small Diameter; and Representative Failures. Specimens at Left are With the HAE Heavy Anodic Coating (M8). Failed Specimens are Coated With the DOW 17 Light Anodic Coating (M11).

Some minor fretting damage at the grip taper is normal for this test due to the action of dynamic strains in the contact points at the grip taper, however, the fretting between the magnesium and steel surfaces is much more severe than normally experienced in tests of other materials. This problem necessitated redesign of the specimen for a smaller test section diameter that would provide consistently valid high cycle failures. Analysis of the data indicated a close design relationship between fretting damage susceptibility, test load level, and test machine minimum loading limitations. This led to the conclusion that only a very small range of values around 0.300-in. diameter would yield satisfactory testing of magnesium rotating beam specimens. The redesigned specimen shown in figure 1 was decided upon having a minimum test section diameter of 0.305-in. (7.7 mm) with a 5-1/4-in. (133 mm) radius. Typical finished specimens are shown in figure 30.

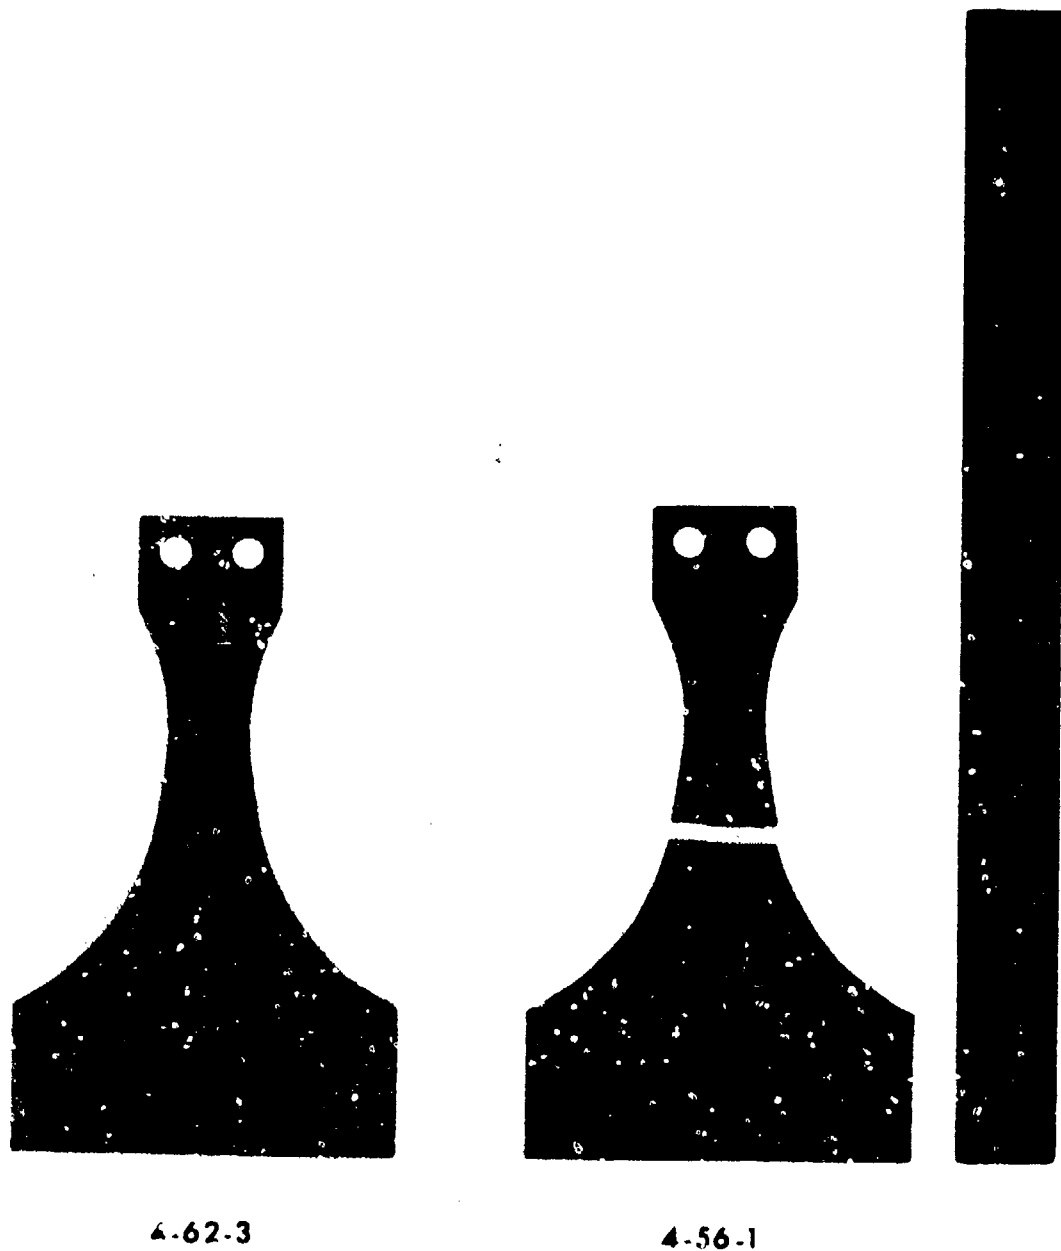
Figure 45 - Typical 1/8-In. (3.2mm) Thick Sheet Flexure Fatigue Test Specimen and Representative Failure. Specimens are ZE41 Alloy, HAF Heavy Anodic Coated (C5).
